Manhole Inspection Summary

Manhole # S21UU1022MH

Insp Date: **3/29/07 10:31 AM**

Location Address: **5007 FALLS ROAD TERR**

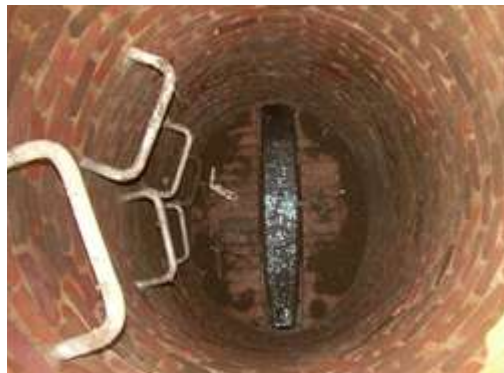
Top View

Corbel and Barrel infiltration. Corroded steps. Bench debris.

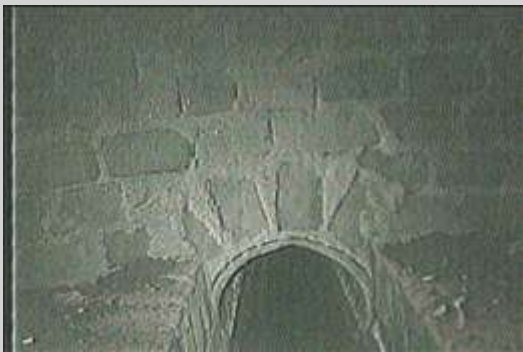
8 in. Circular Gravity Sewer Pipe Out @ 12 O'Clock

Deposits: ☐ None ☐ Mud ☐ Sludge ☐ Debris ☒ **Grease**

Silt Depth: **0** (in.) Deposits Extent: **Light**

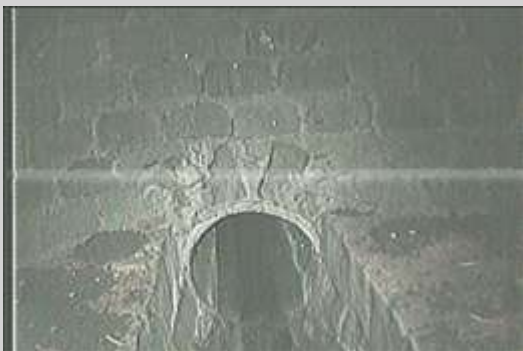
8 in. Circular Gravity Sewer Pipe In @ 6 O'Clock

Deposits: ☐ None ☐ Mud ☐ Sludge ☐ Debris ☒ **Grease**

Silt Depth: **0** (in.) Deposits Extent: **Light**
